ROOT CAUSE FAILURE ANALYSIS INVESTIGATION REPORT

Weymouth Compressor Station September 30, 2020 Blowdown Event

**Algonquin Gas Transmission, LLC
Subsidiary of Enbridge Inc.**

Report No.: 10263555-2, Rev. 0

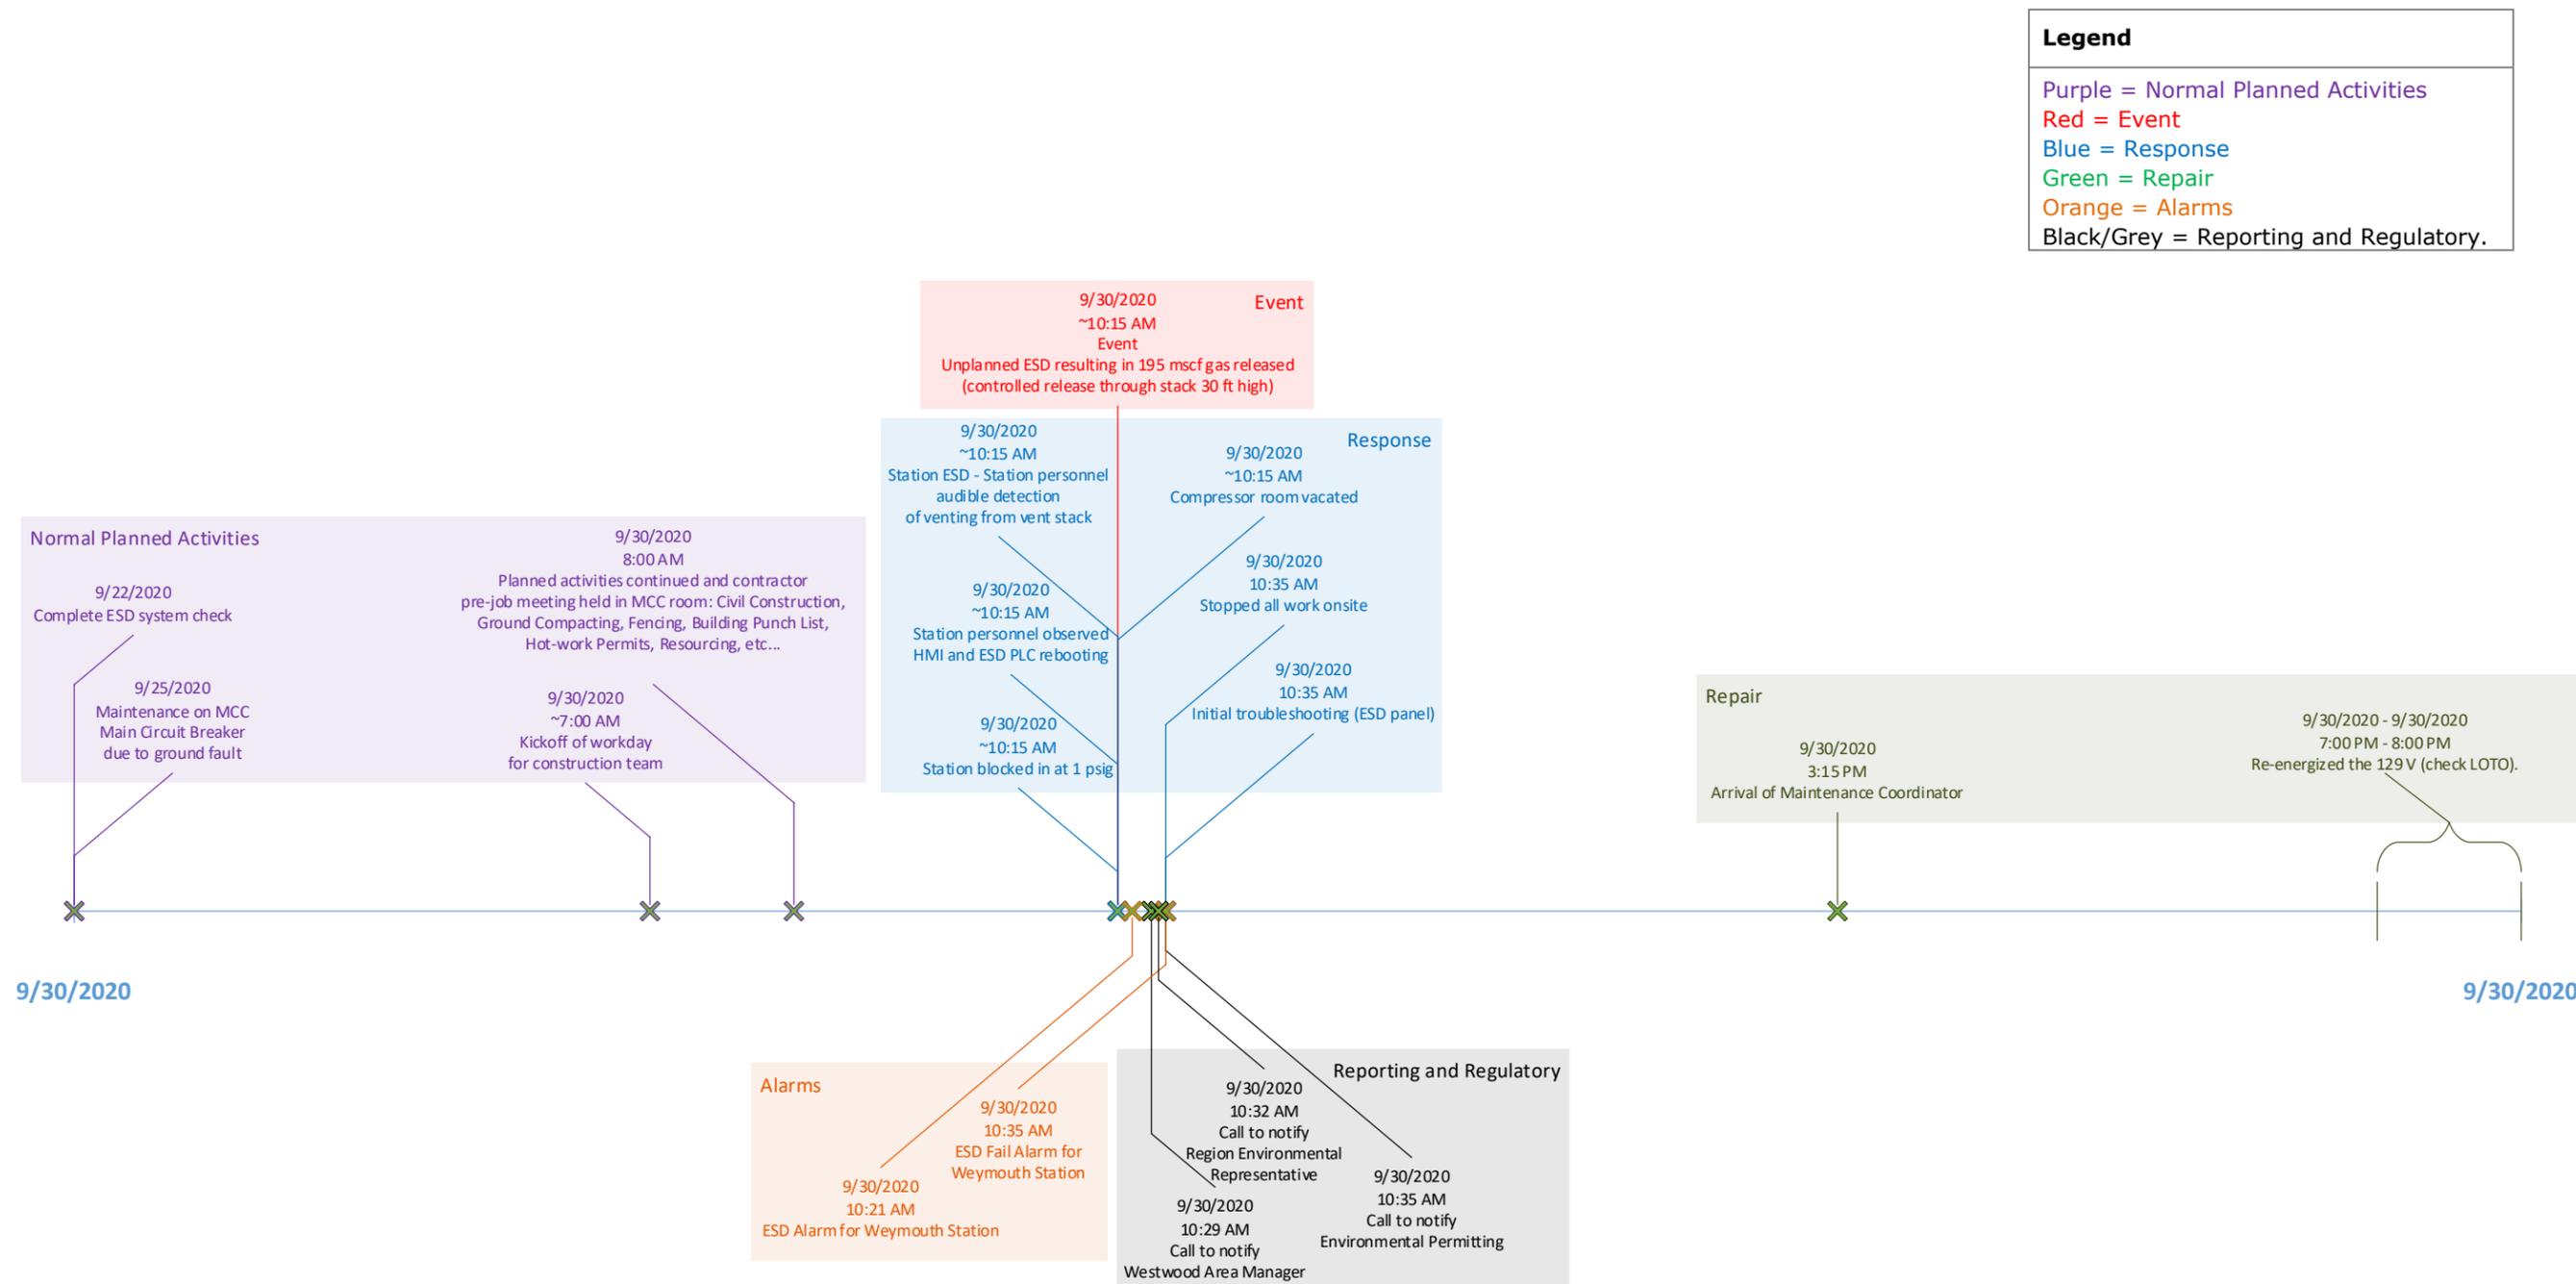
Figure 3: Timeline showing key events/activities on the day of the ESD event, September 30, 2020.

At approximately 10:15 a.m., an ESD at the compressor station resulted in the controlled release of 195 mscf of natural gas through a 30-foot tall vent stack. This ESD, and subsequent venting, was the focus of the investigation. The ESD system is designed to protect the public, employees, and critical pipeline and facility components from abnormal operations by safely releasing natural gas to a remote vent stack, away from ignition sources and areas where the gas may cause harm. In this case, the ESD and blowdown were activated, and the system worked as intended.

During the event, station personnel audibly detected venting from the surge reliever and observed the human machine interface (HMI) and ESD programmable logic controller (PLC) rebooting. Immediately afterward, the compressor building was vacated in accordance with response procedures, and the station was blocked in (shut in) to 1 psig natural gas pressure.

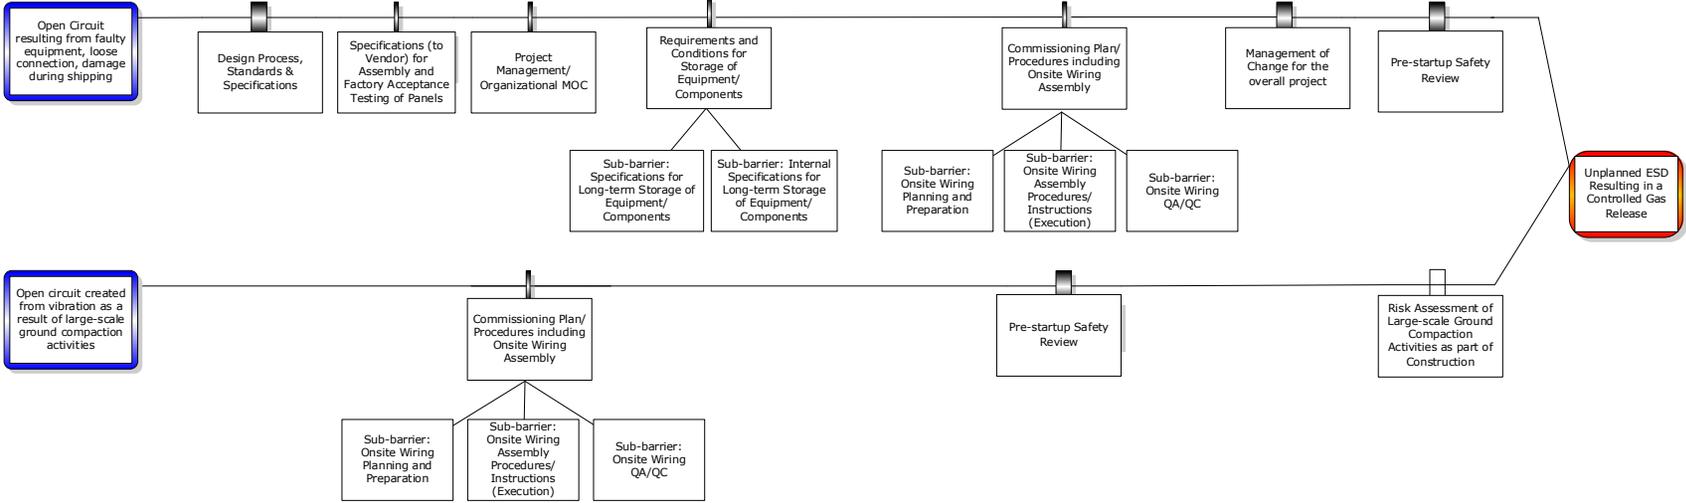
Figure 9: Simplified BSCAT™ Diagram showing the barriers evaluated for the ESD Event.

The conclusions of this investigation are based on an assessment of the preventive barriers (intended to reduce the likelihood of an event) illustrated in the simplified diagram depicted in Figure 9, and discussed in Section 5.1. The complete BSCAT™ diagram, which can be found in Appendix A, includes the full causation for each barrier that contributed to the event.

For the **open circuit resulting from faulty equipment, loose connection, or damage during shipping** (referred to as the “open circuit” scenario), five (5) barriers were determined to be non-causal to the event, and two (2) barriers, highlighted in **yellow**, were determined to contribute to the scenario, as shown in Table 2.
