**Principal Investigator** Gery Bauman  
**Region Director** David Barrett  
**Date of Report** 6/4/2012  
**Subject** Failure Investigation Report – BP Oil Pipeline, External Corrosion, Interference

Failure Investigation Report – BP External Corrosion Bromley-Cincinnati 6”  
Failure Date 02/25/2004

Executive Summary

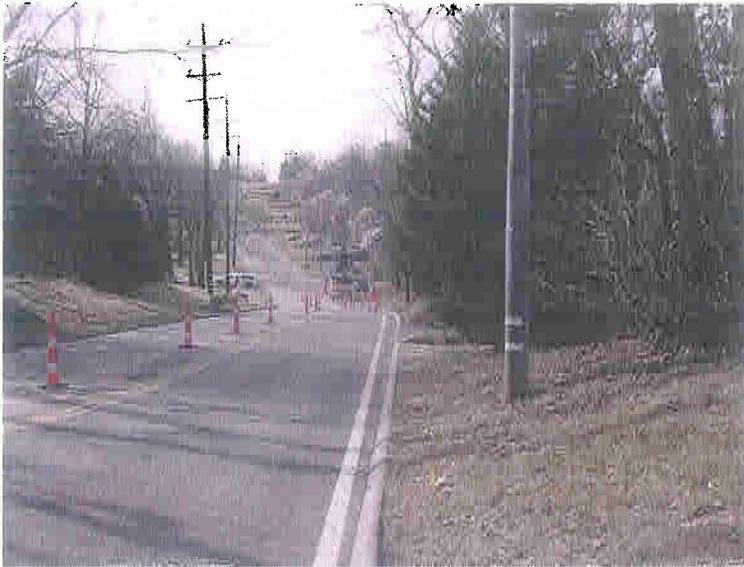
Photo 1 - View looking south on Anderson Ferry Road at leak site.

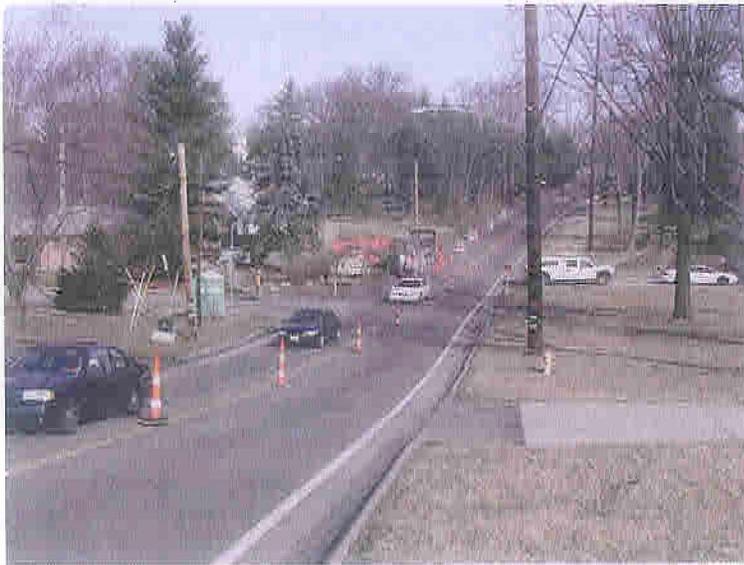
Photo 2 - View looking north at leak site.

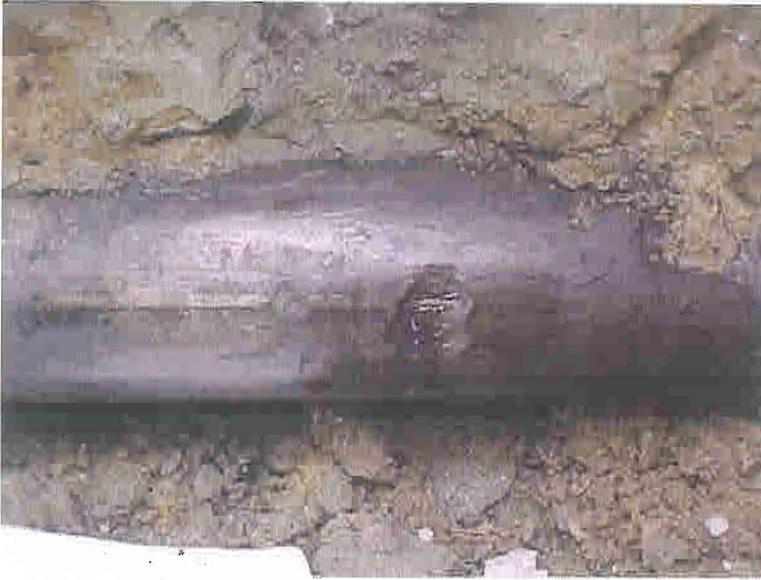
The pipe failure was at the 10 o’clock position. Microbial Induced Corrosion (MIC) was not a factor. MIC was determined not to be present only after chemical and bacterial analysis of deposits near the leak and soils were completed (chemical analysis of deposits found in the pits near the leak, bacterial testing of deposits under the coating, and soil samples).

Kiefner and Associates completed a metallurgical investigation of the pipe. The metallurgical analysis identified that the cause of the leak was external corrosion “with some mild acceleration of corrosion on the seam due to selective seam corrosion.” The metallurgical analysis also suggested that if corrosion growth rates did increase as initially thought, then “the change that took place was related to the installation of a cathodic-protection rectifier in 2002 and/or other electrical interference on the line.” This was supported by the fact that the copper water lines were visually found to be in direct contact with the pipeline when the excavation of the leak site occurred. The metallurgical report indicated that “corrosion had reached a depth of approximately 95 percent through wall before the leak occurred.”

Photo 3 – Leak origin.

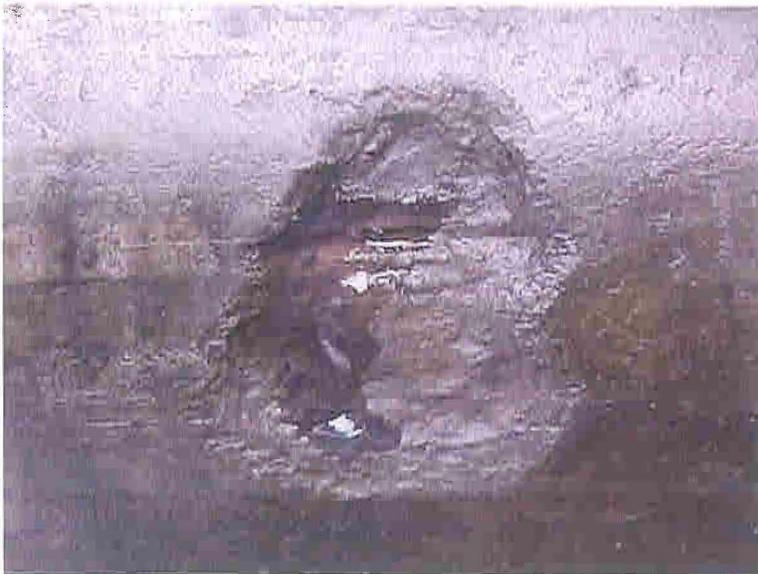
The metallurgical analysis identified that the cause of the leak was external corrosion “with some mild acceleration of corrosion on the seam due to selective seam corrosion”. The metallurgical analysis also suggested that if corrosion growth rates did increase as initially thought, then the analysis suggested “the change that took place was related to the installation of a cathodic-protection rectifier in 2002 and/or other electrical interference on the line.” The report indicated “corrosion had reached a depth of approximately 95 percent through wall before the leak occurred.”

Photo 4 – Close-up of corrosion pit.

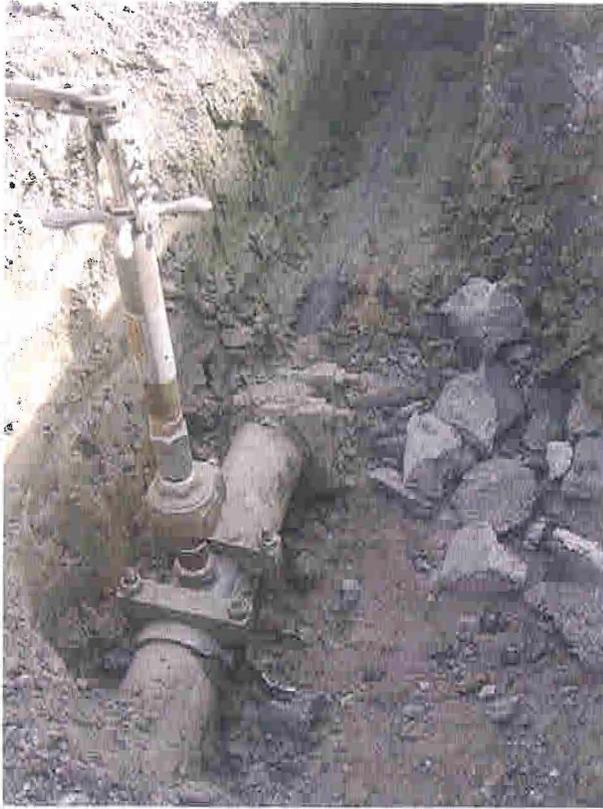
Photo 5 shows temporary leak clamp and stopple fitting used to drain pipeline in preparation for the pipe cut out.

Once the specific location of the leak was identified, the pipe was temporarily repaired by the use of a bolt on leak clamp. When temporary repairs were finished, permanent repair plans were developed. The operator's repair plan included the drain down of the pipeline and the installation of new pipe to replace portions of the pipe in the area that had leaked. BP installed and replaced 47 feet of old pipe with new pipe. A CAO, CPF 3-2004-5005H, was issued on March 2, 2004 and encompassed requirements that impacted the return to service plan.

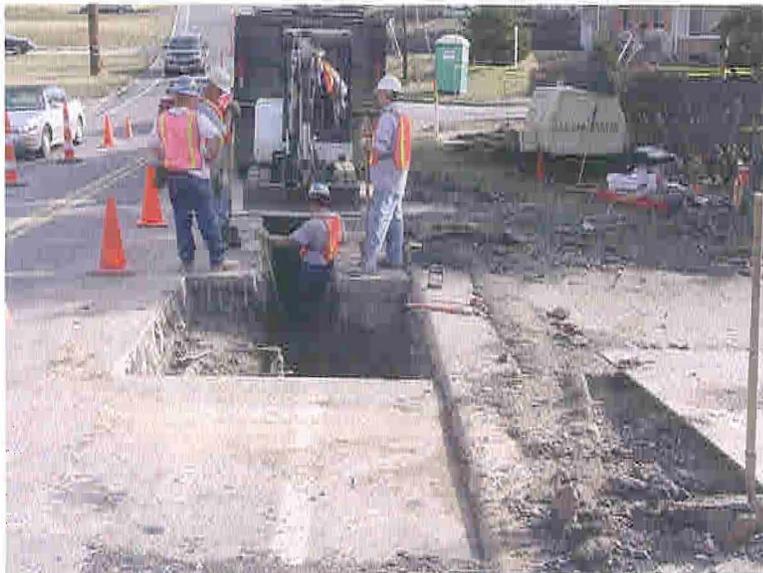
Photo 6 shows bell hole through pavement, top of stopple fitting is visible.
