**Principal Investigator** Michael Yazemboski  
**Senior Accident Investigator** Michael Yazemboski  
**Region Director** Byron E. Coy  
**Date of Report** 2/11/2016  
**Subject** Failure Investigation Report—Buckeye Linden Station, Internal Corrosion Leak, 8-inch Relief Line

# Failure Investigation Report—Buckeye Linden Station Internal Corrosion Leak, 8-inch Relief Line

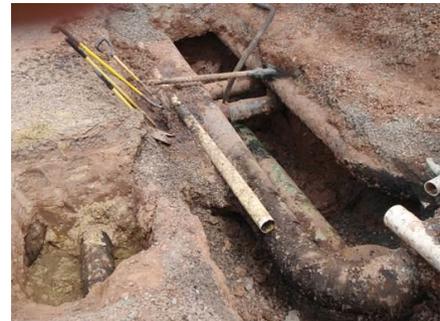
Metallurgical analysis of the leaking pipe section identified two leak locations with internal corrosion pits at the 6 o'clock position on the pipe. The largest leak location (Leak #1) was approximately 0.59 inches longitudinally and 0.51 inches circumferentially. Five additional pits (that did not penetrate the pipe wall) were also identified in the 6 o'clock position, with the largest pit measuring 0.71 inches longitudinally, 0.47 inches circumferentially, and 0.30 inches deep.

Based on the metallurgical analysis performed by DNV-GL, the apparent cause of the leak was corrosion due to microbial action on the internal surface of the pipe at the 6 o'clock position (Appendix D). There was no evidence of significant external corrosion on the pipe section.

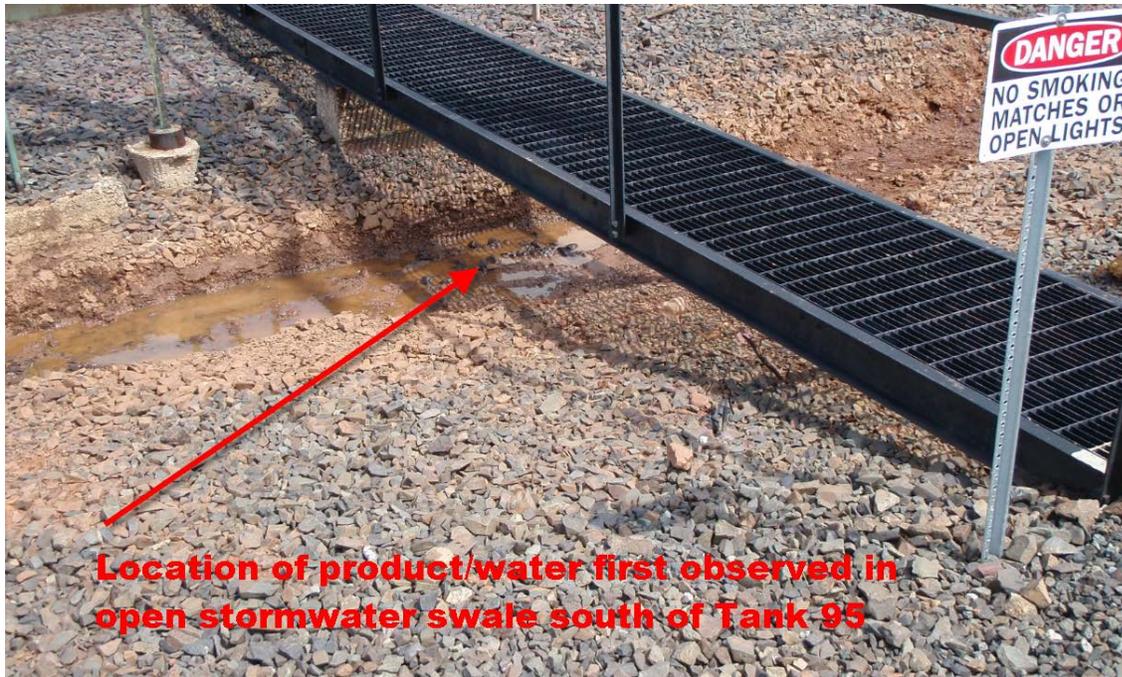
**Location of product/water first observed in open stormwater swale south of Tank 95**
