**Principal Investigator** Darren Lemmerman  
**AID Director** Peter Katchmar  
**Date of Report** April 2, 2018  
**Subject** Failure Investigation Report: Third-party damage to Natural Gas Pipeline Company of America (NGPL) pipeline operated by Kinder Morgan

# Failure Investigation Report: Third-party Damage to a Kinder Morgan-operated NGPL Pipeline Dixon, Lee County, Illinois

Failure Date: December 5, 2017

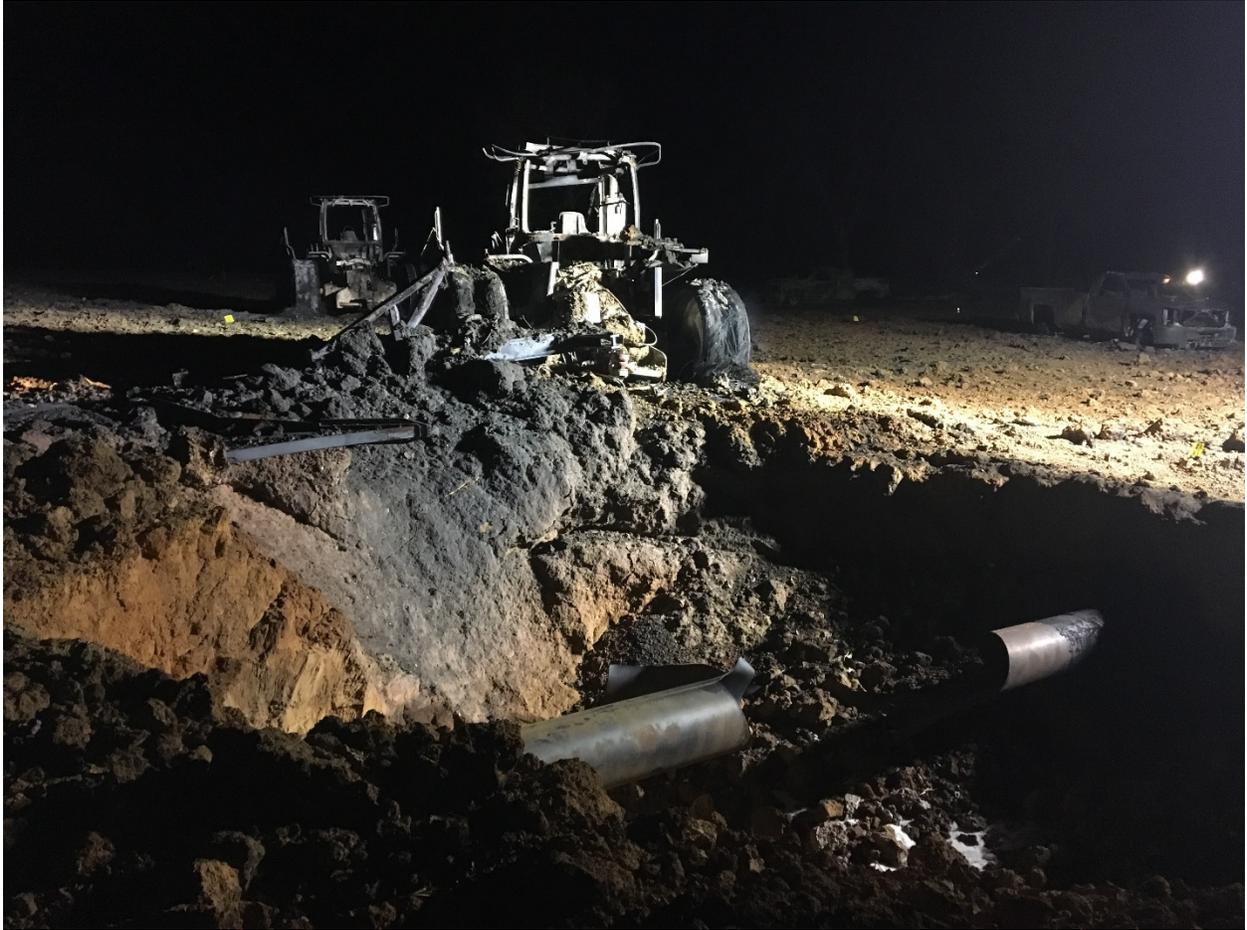
Looking SW at the two tractors used to pull the tiling plow with ruptured pipeline.

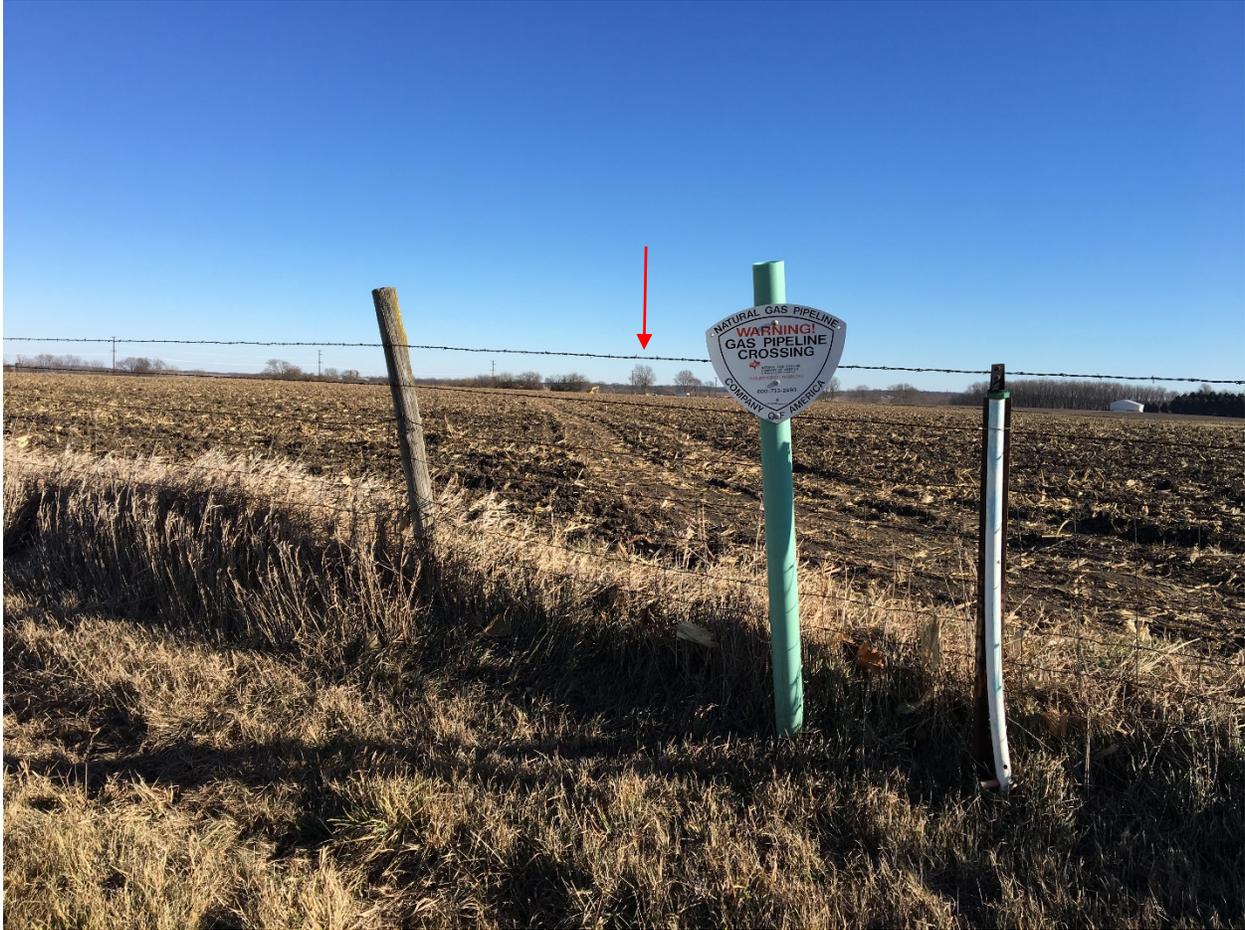
Looking East at the NGPL line marker and down the ROW from Nachusa Road. Rupture occurred at tree line in photo, see arrow.

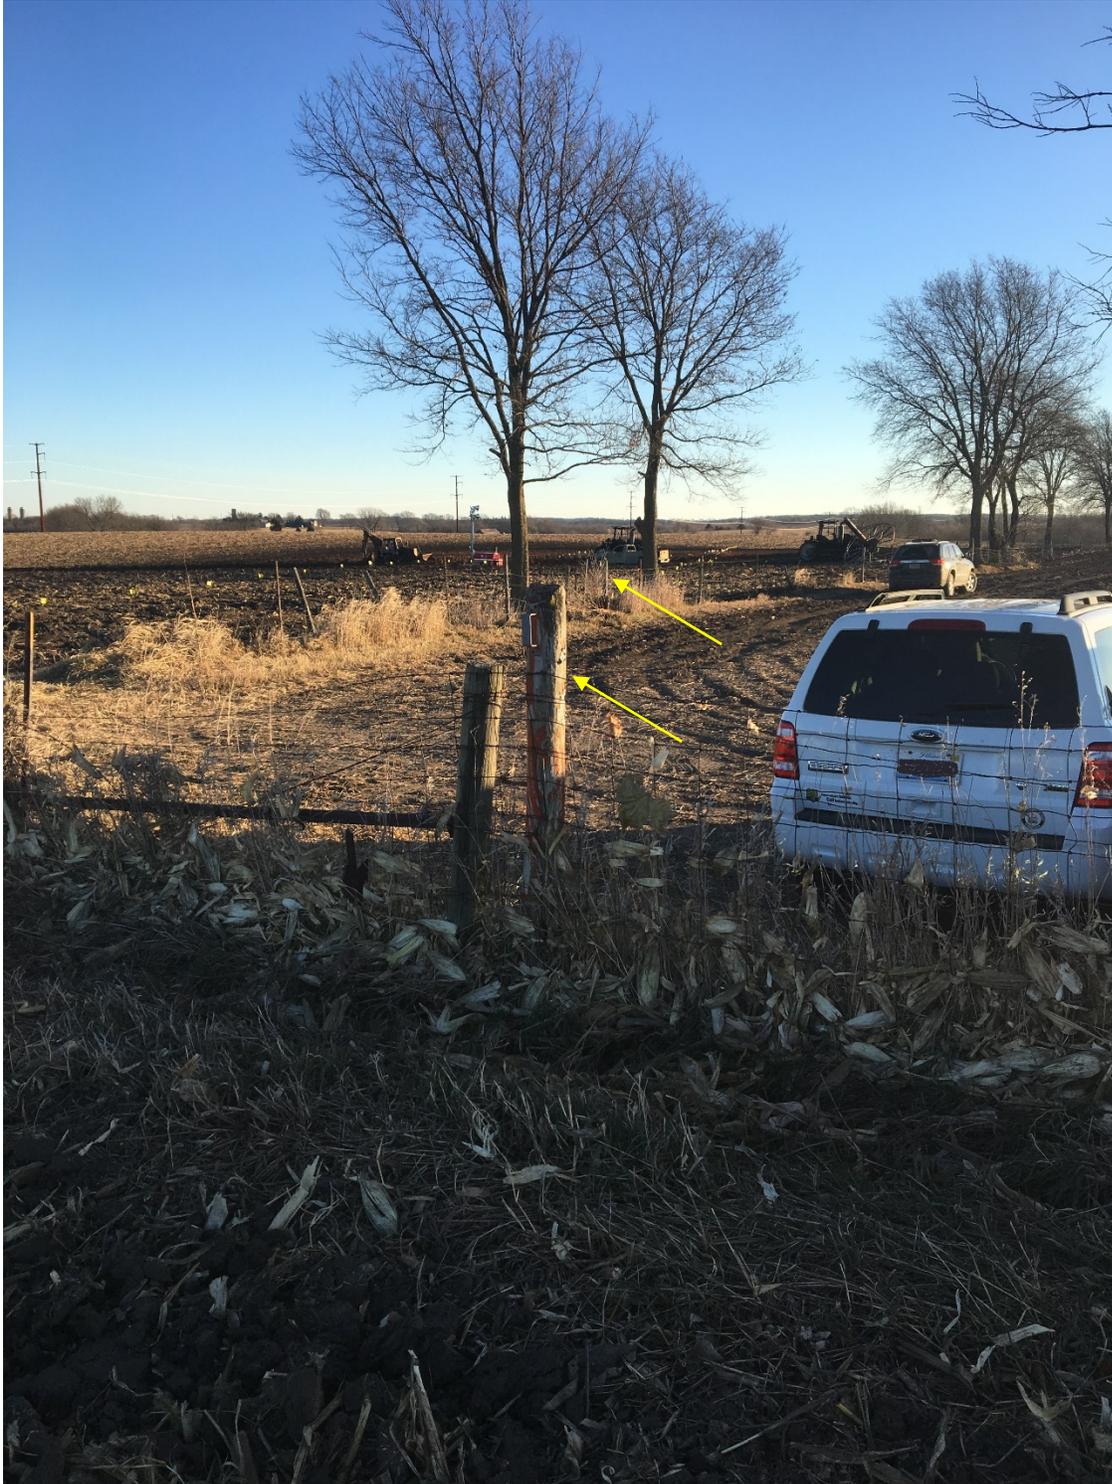
Looking NE at Rupture site. Yellow arrows are pointing at the two unmaintained line markers for line 2. Yellow locating flags can be seen for the two lines. The lines were marked and located after the accident.

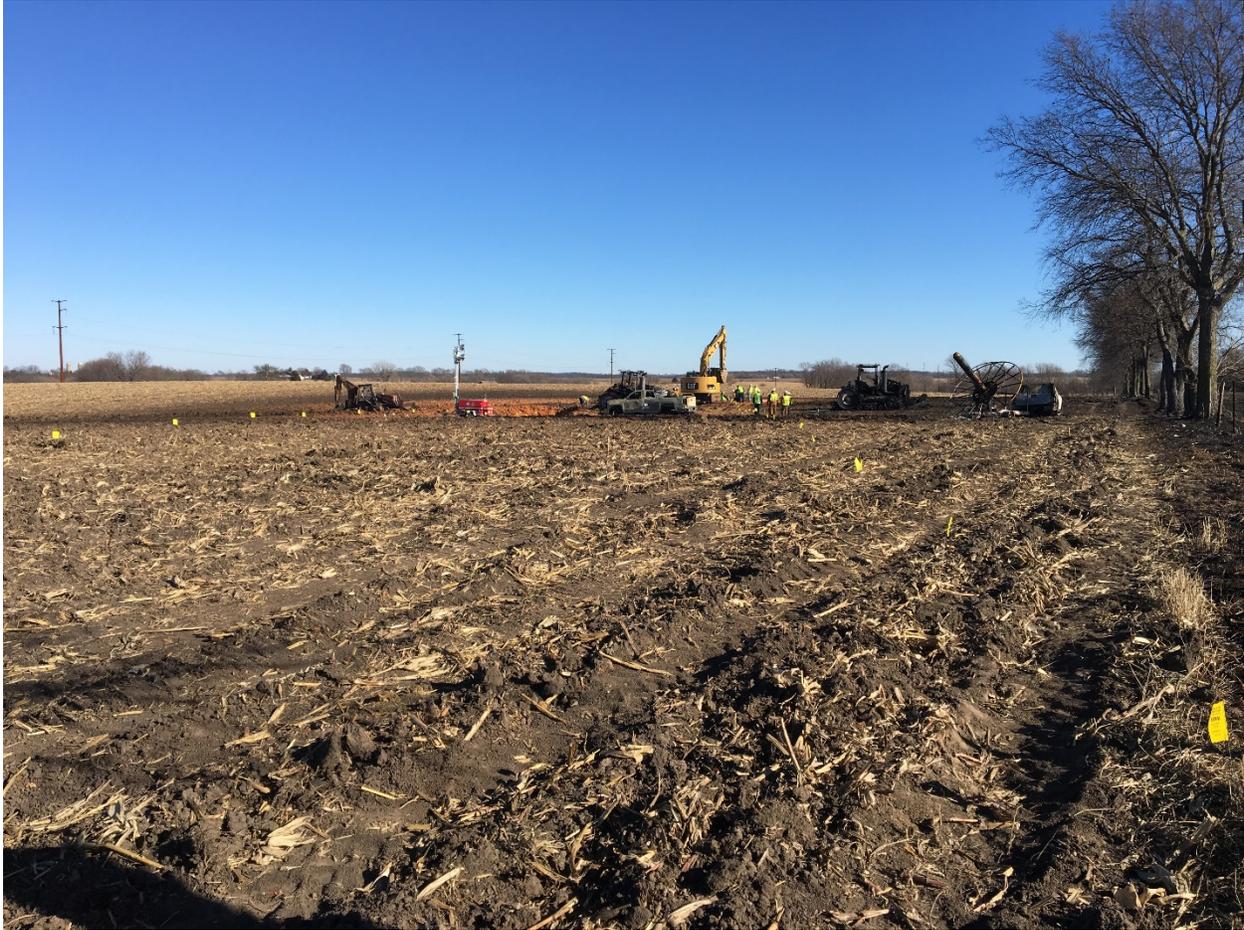
Looking NE at the rupture site. Line locating flags can be seen that were installed after accident. Backhoe on the left, two tractors, two trucks and a tiling spool trailer can be seen damaged. NGPL is currently excavating line 2 and checking for possible damage prior to working on line 1.

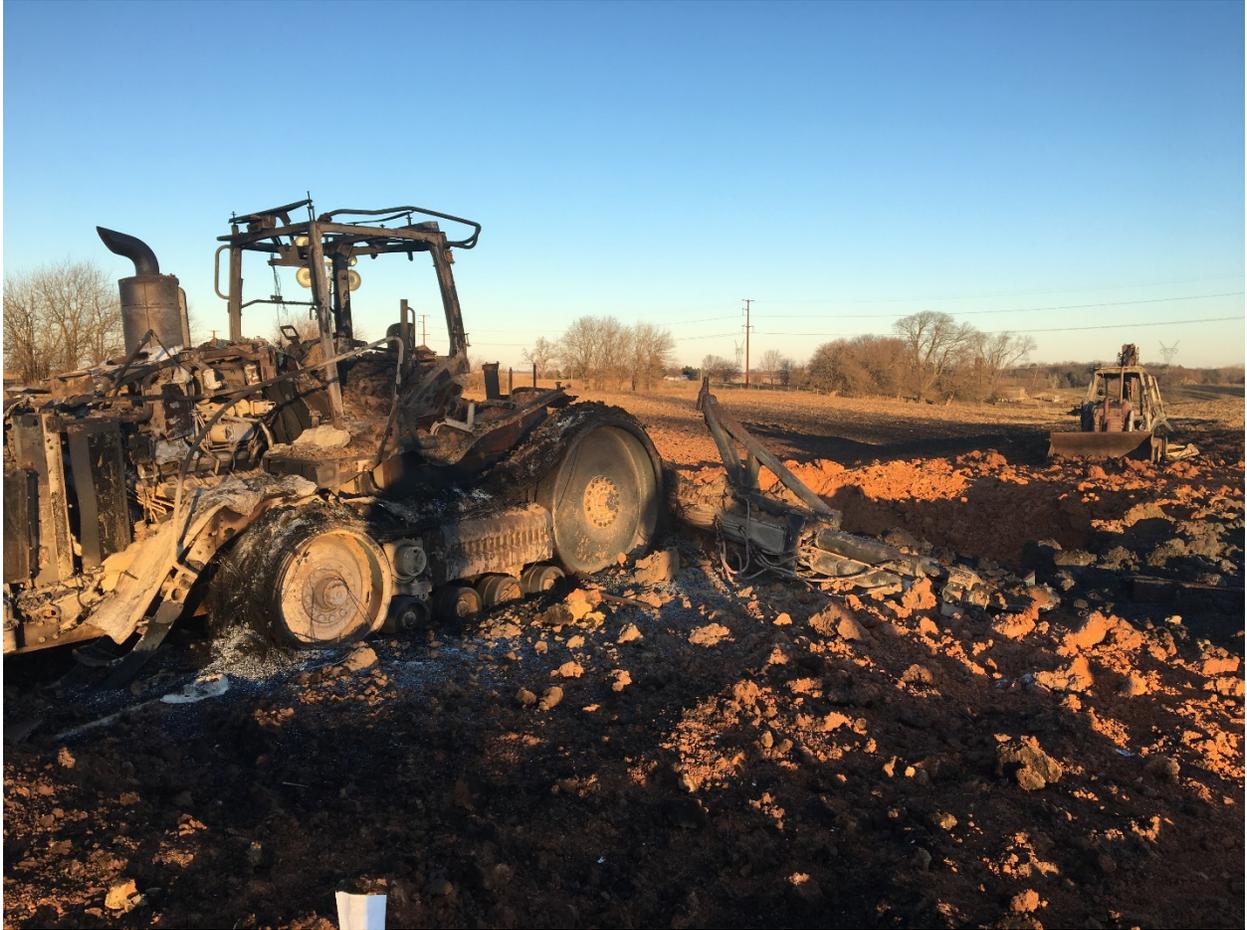
Looking North at the tractor that was pulling the tiling plow and the tiling plow can be seen blown to the side of the tractor. Backhoe is in back ground.
